**RAMP COLLISION, RWANDAIR FLIGHT 205, OPERATED BY JETLINK  
BOMBARDIER CL-600-2B19, REGISTRATION 5Y-JLD, KIGALI INTERNATIONAL  
AIRPORT,  
12 NOVEMBER 2009**

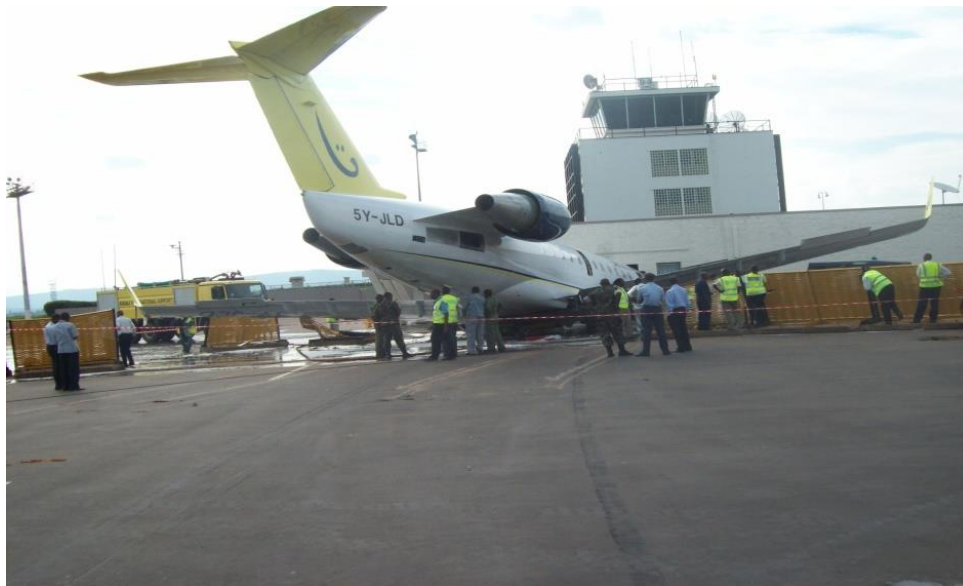
The aircraft was substantially damaged. Wings detached from the front attachment points. The aircraft nose section and the cockpit area were damaged.

**Photo 1.** Left rearview of aircraft wreckage

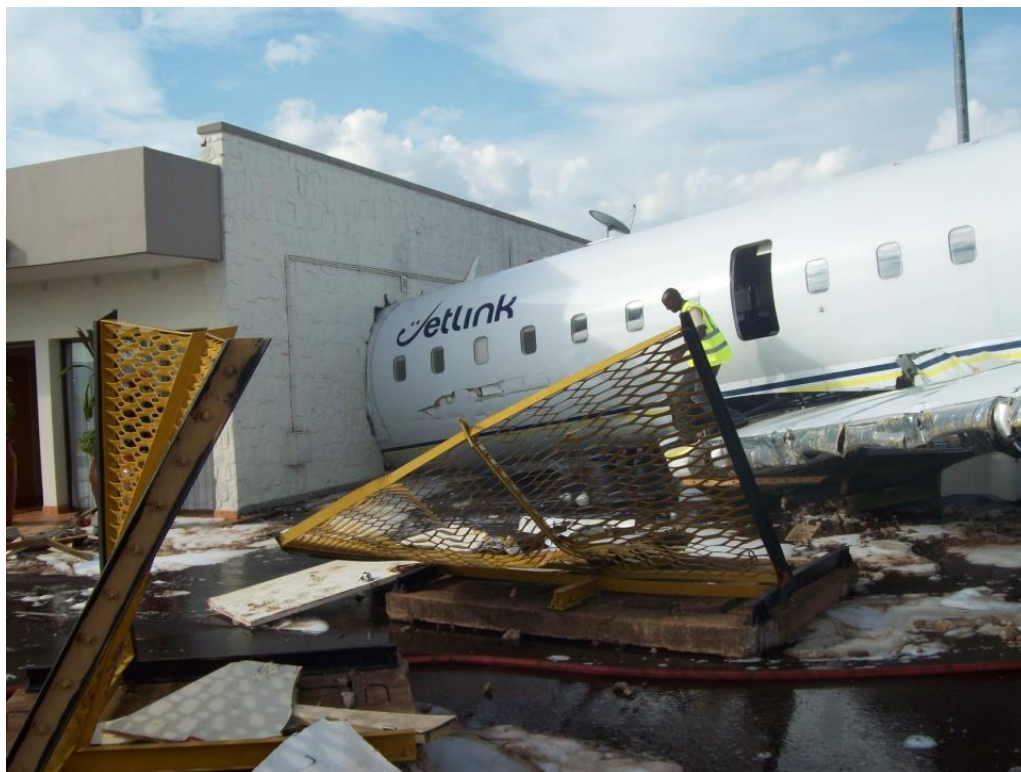
**Photo 2.** Left side view of aircraft wreckage (above)

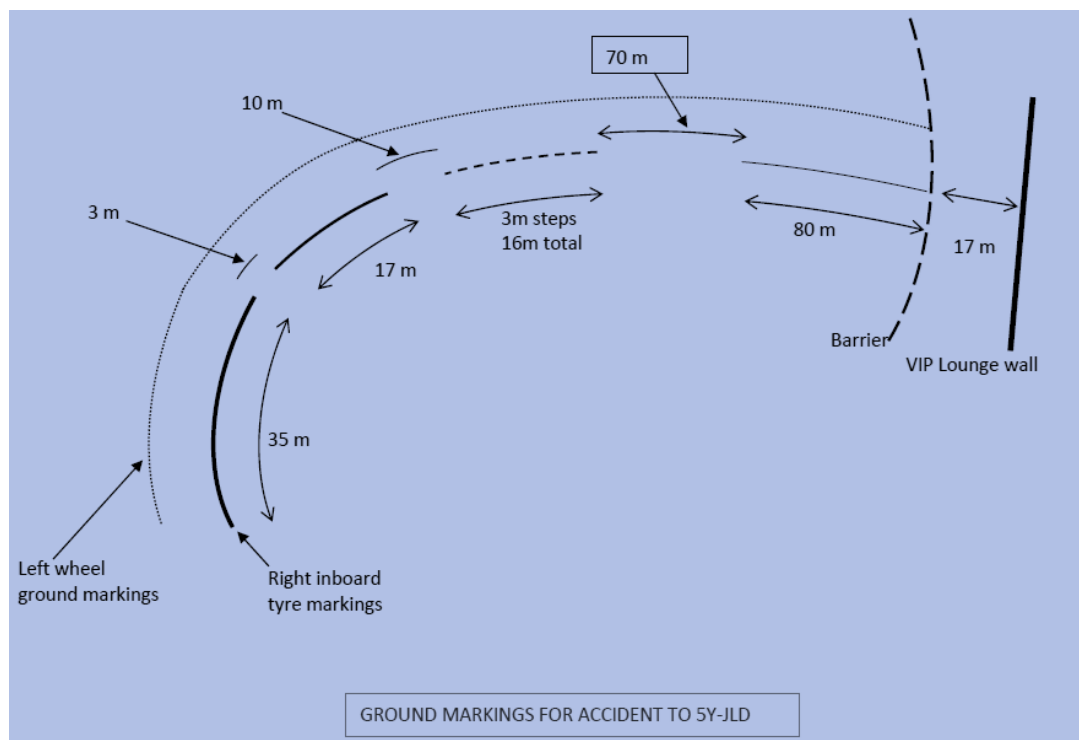
The skid marks on the ramp shows there was braking on the right tire as compared to the left tire, which appears to have caused scrapping damage to the tarmac, and it would explain why the airplane turned right during the accident sequence that followed the inadvertent movement of the airplane after it was parked.

The airplane, which was generally intact, was located with its front section penetrated through the wall structure of the air traffic control tower building. Along the path on the ramp where the airplane had parked to the accident site was surface damage associated with the landing main gear wheels over a distance of 220 meters that transitioned about 80 degrees from a south to west direction (see Figure 1).

**Figure 1:** Ground Markings (Below)

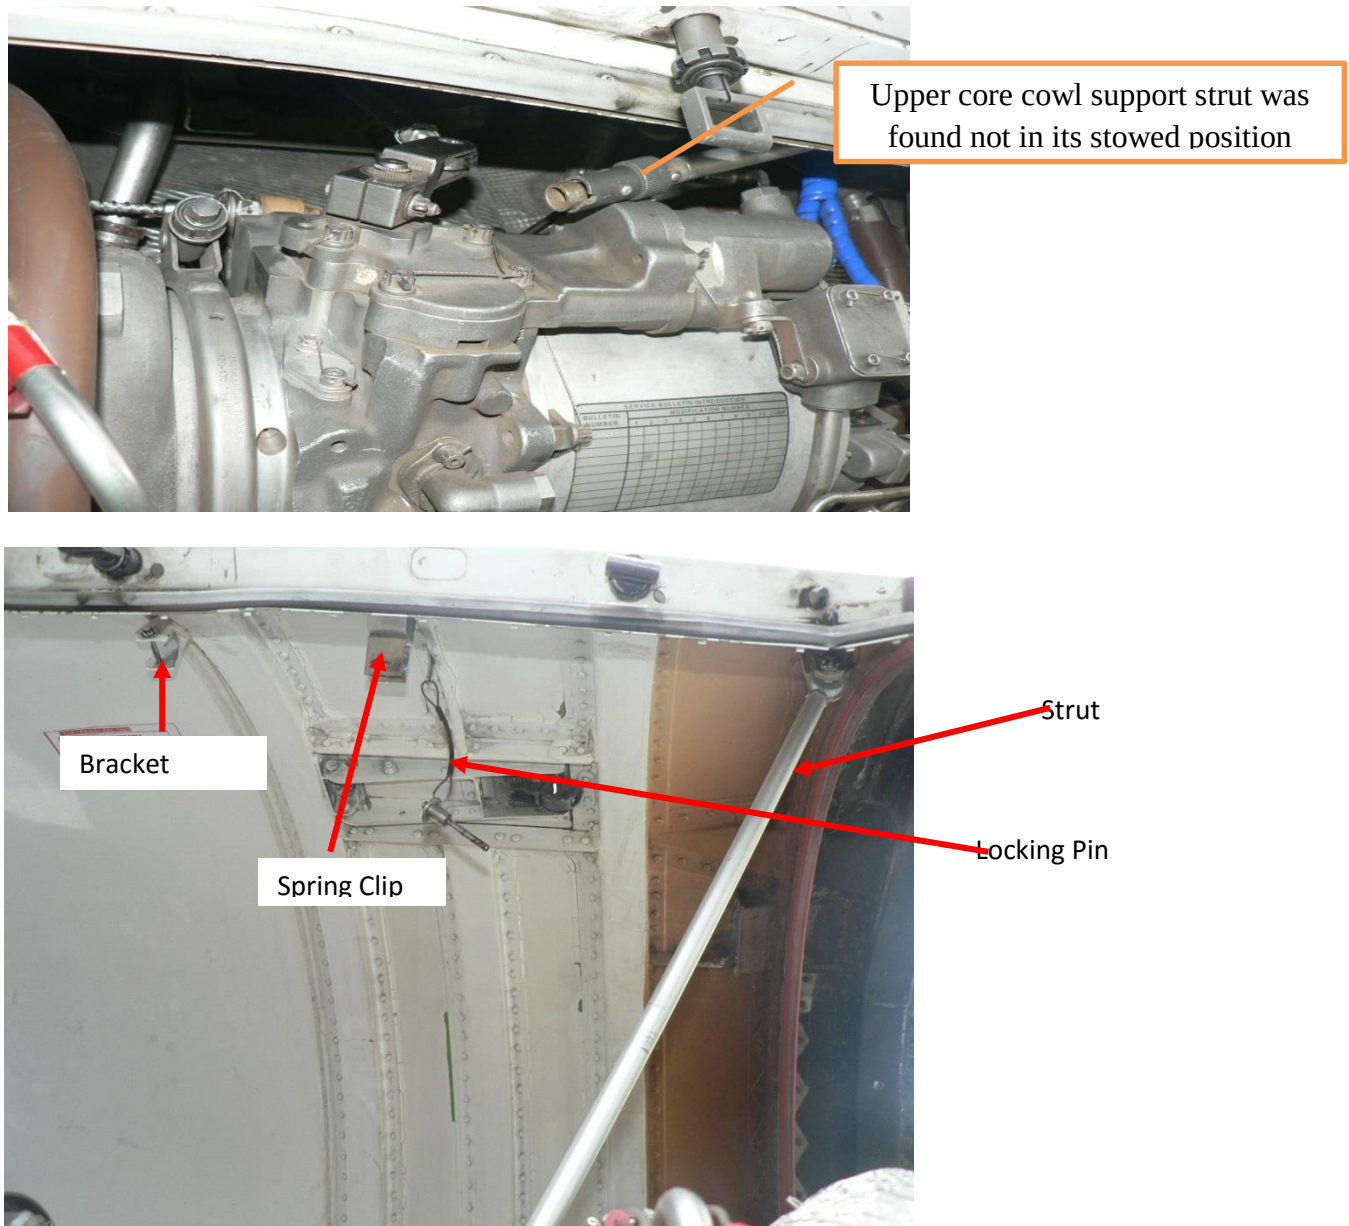
Examination of the left engine revealed the throttle mechanism was in the idle position, the upper core cowl support strut not in its stowed position and the safety pin hanging from its lanyard as indicated in number 3 photo below. The strut was in a position to prevent movement of the fuel control unit actuating arm less than the 93% N1. The components of the strut stow assembly, consisting of the locking collar, spring clip, and lock pin were inspected and no evidence of mechanical malfunction was revealed. Continuity was established between the left engine thrust lever and fuel control unit

**Photo 3.** View of Upper Core Cowl Door Hold Open Rod found dislodged.

- 3.1.3** The weather was not a factor.
- 3.1.4** The core strut, which was found in the not stowed position, interfered with the left engine throttle lever during takeoff resulting in a jammed thrust lever.

- 3.1.6** The design feature of the left engine upper core cowl support in relation to the engine throttle mechanism is a safety hazard as it is prone to interfering with the engine throttle mechanism whenever it is in its unsecured position. The aircraft design organization mitigated the risk by conducting several discretionary modifications (except one recommended service bulletin number 601R-71-026) and providing a TLJ (Throttle Lever Jammed) procedure in the aircraft flight manual, flight crew operating manual QRH.

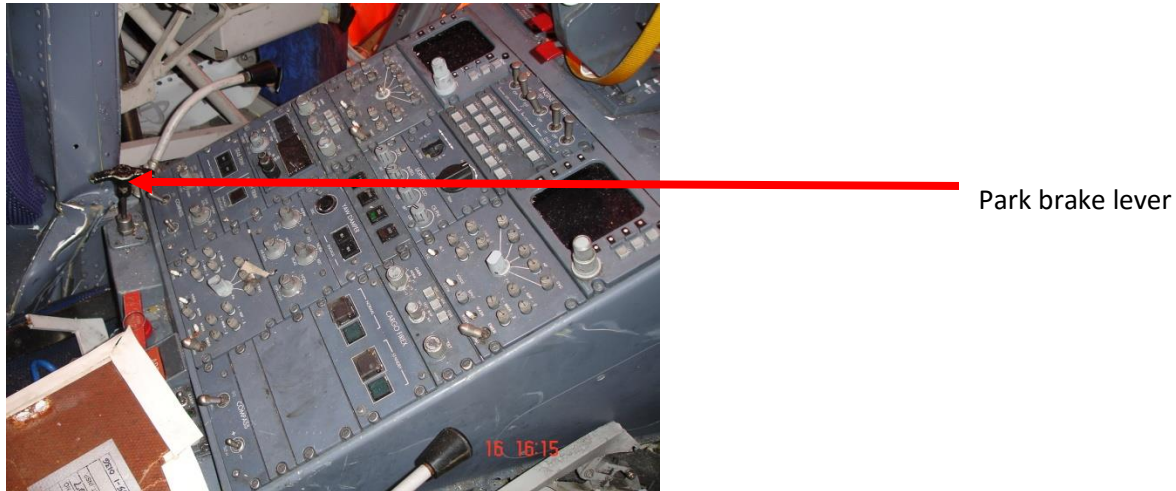
Inspection of the parking brake lever indicated that it was pulled up and engaged in the 90 degree locked position, as required for engaging the parking brake.

**Photo 4.** View of Parking Brake in the Park Brake Engaged Position

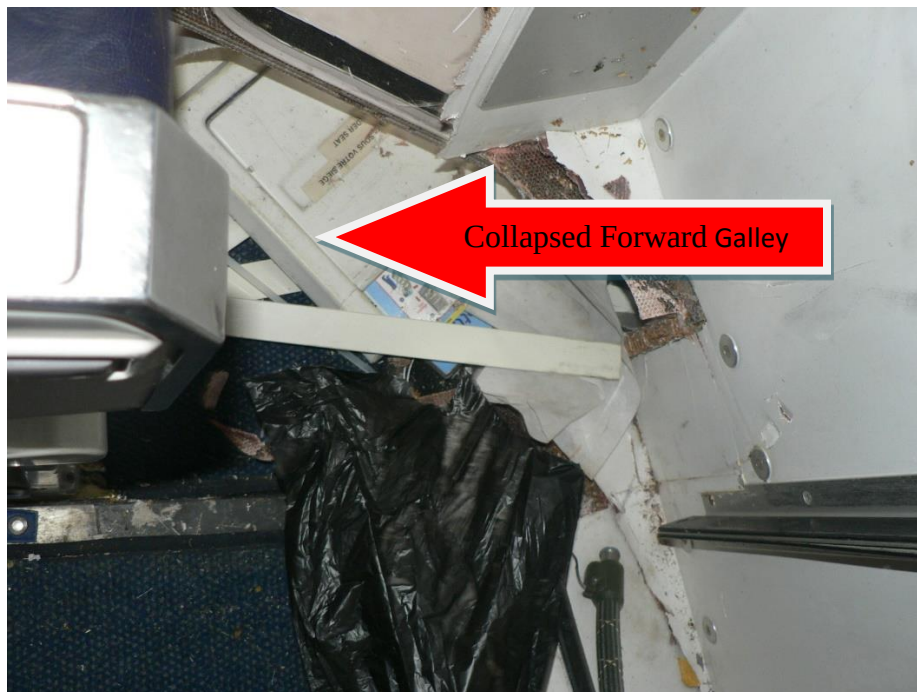
The post impact damage resulted in extensive crushing of the forward fuselage and collapse of the galley area, obstructing the use of the 1L passenger door. The passengers evacuated the airplane through the right hand over wing (RHOW) emergency exit. Several of the passengers exited the airplane with the assistance of the cabin crew.

**Photo 5.** View of Collapsed Forward Galley

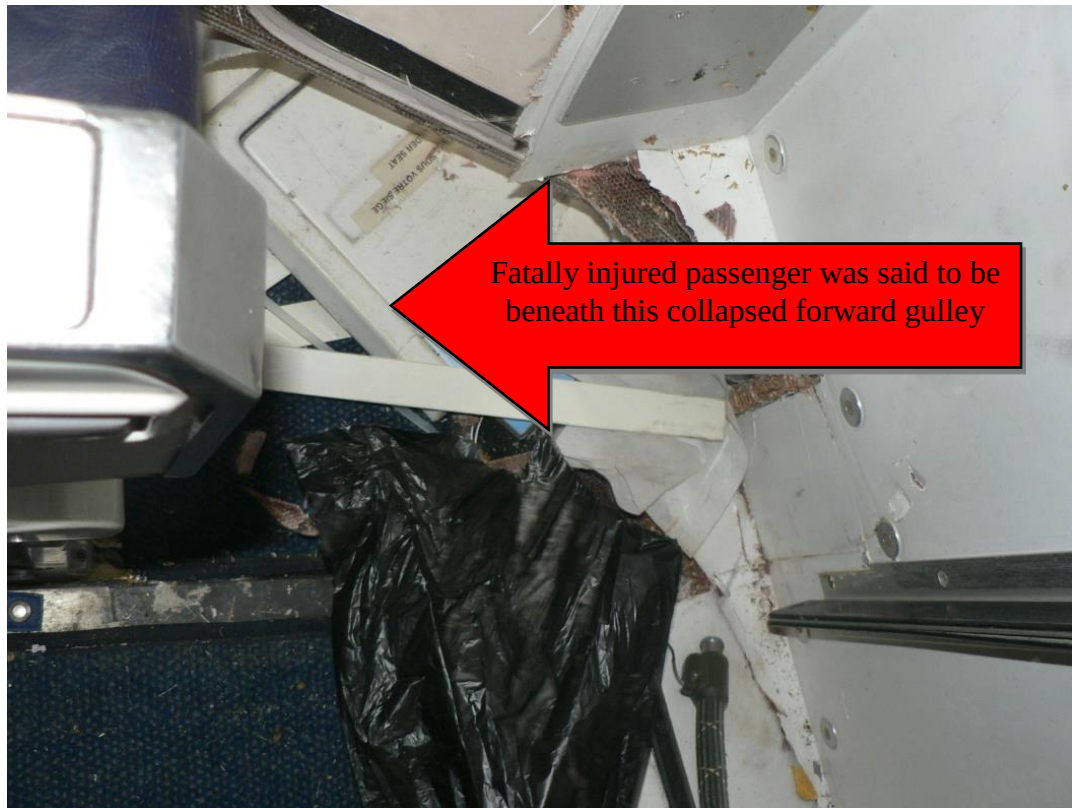
After evacuating all other passengers, rescue officers/cabin crew researched the cabin and found one more passenger (lady) lying unconscious under the collapsed forward galley. The fire officer

**Photo 6.** Showing place where one passenger was located.
