**AIRCRAFT ACCIDENT REPORT  
NUMBER 2011-003**

**GROUND IMPACT, A CHARTER FLIGHT, ROBINSON HELICOPTER R44 II,  
REGISTRATION 9XR-SI, GATARE SECTOR, NYAMAGABE DISTRICT,  
24 AUGUST 2011**

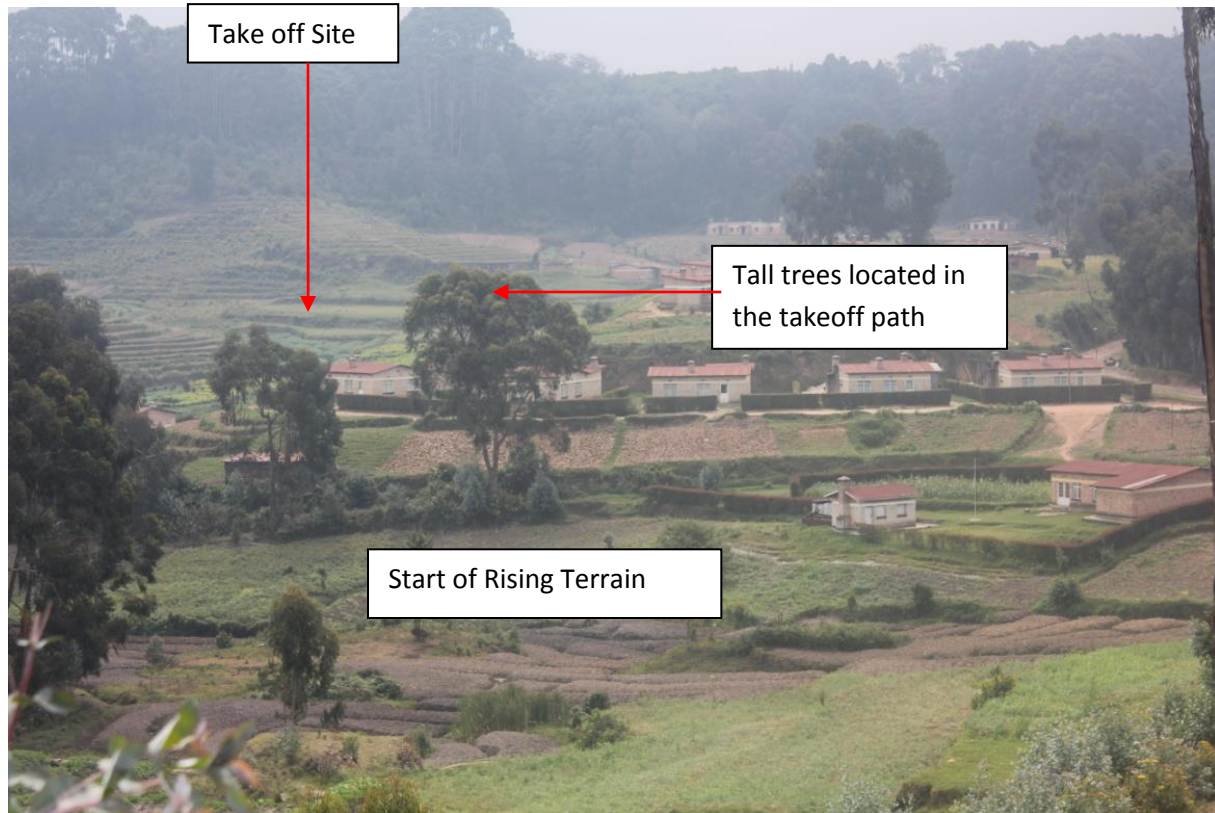
The take off site was a lower ground surrounded by rising terrain and tall trees. The preferred site had a limited open space (about one (1) km) that quickly terminated into a rising terrain.

**Photo 1** showing take off site and available open space (Flight Path)

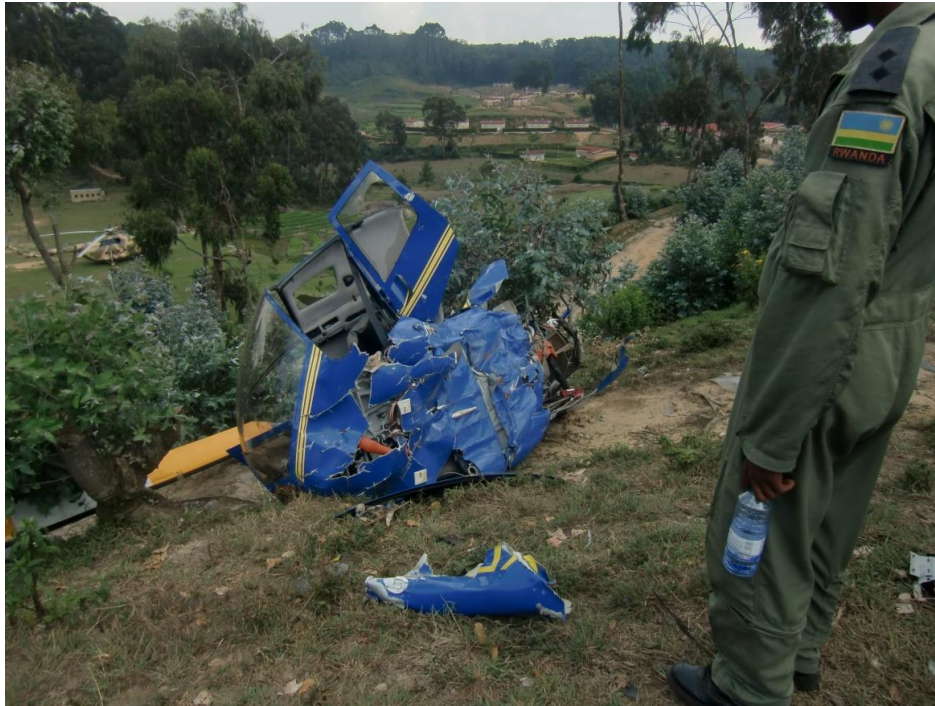
The main wreckage consisting of fuselage, engine, main rotor minus the empennage section, was located midway of the rising terrain flank. The fuselage was positioned with its nose pointing about 095 degrees magnetic.

**Photo 3.** Location of main helicopter wreckage

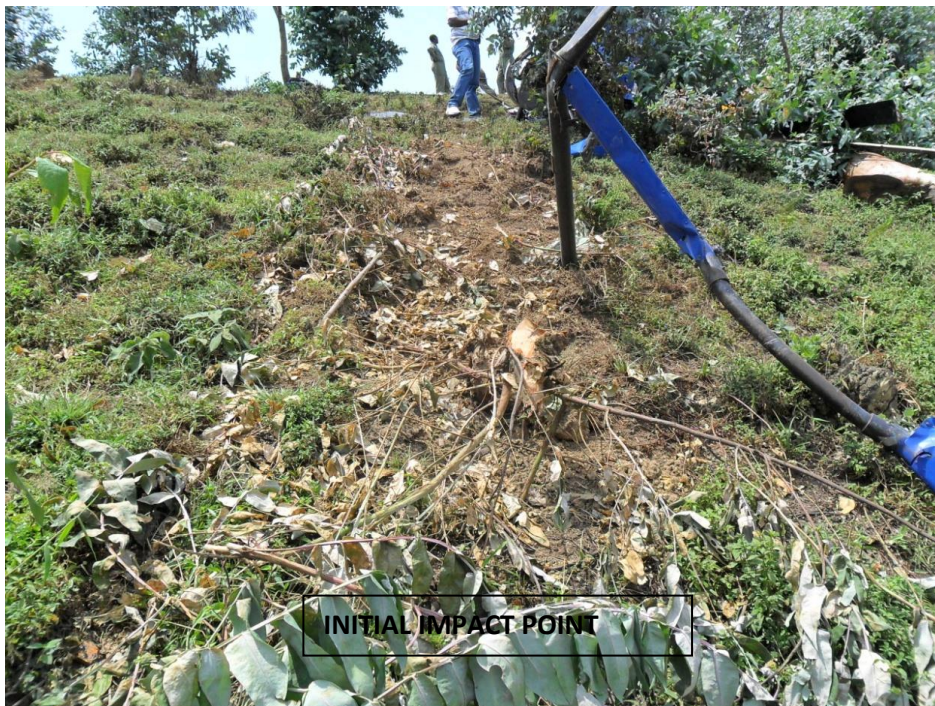
The helicopter impacted with the rising terrain first with the right landing skid, skidded on its belly up the rising terrain for approximately five meters before resting on its right side (see **Photo 4**). The initial impact point was approximately a third way from the bottom of the rising terrain.

The initial impact point showed little ground penetration and slid up the slopes of the terrain for 5 meters before resting on its right side. The skid landing gear, which had had fractured from the attach points, were located around the impact area and along the slide path.

**Photo 4.** Initial Impact point and ground skid marks (Above).

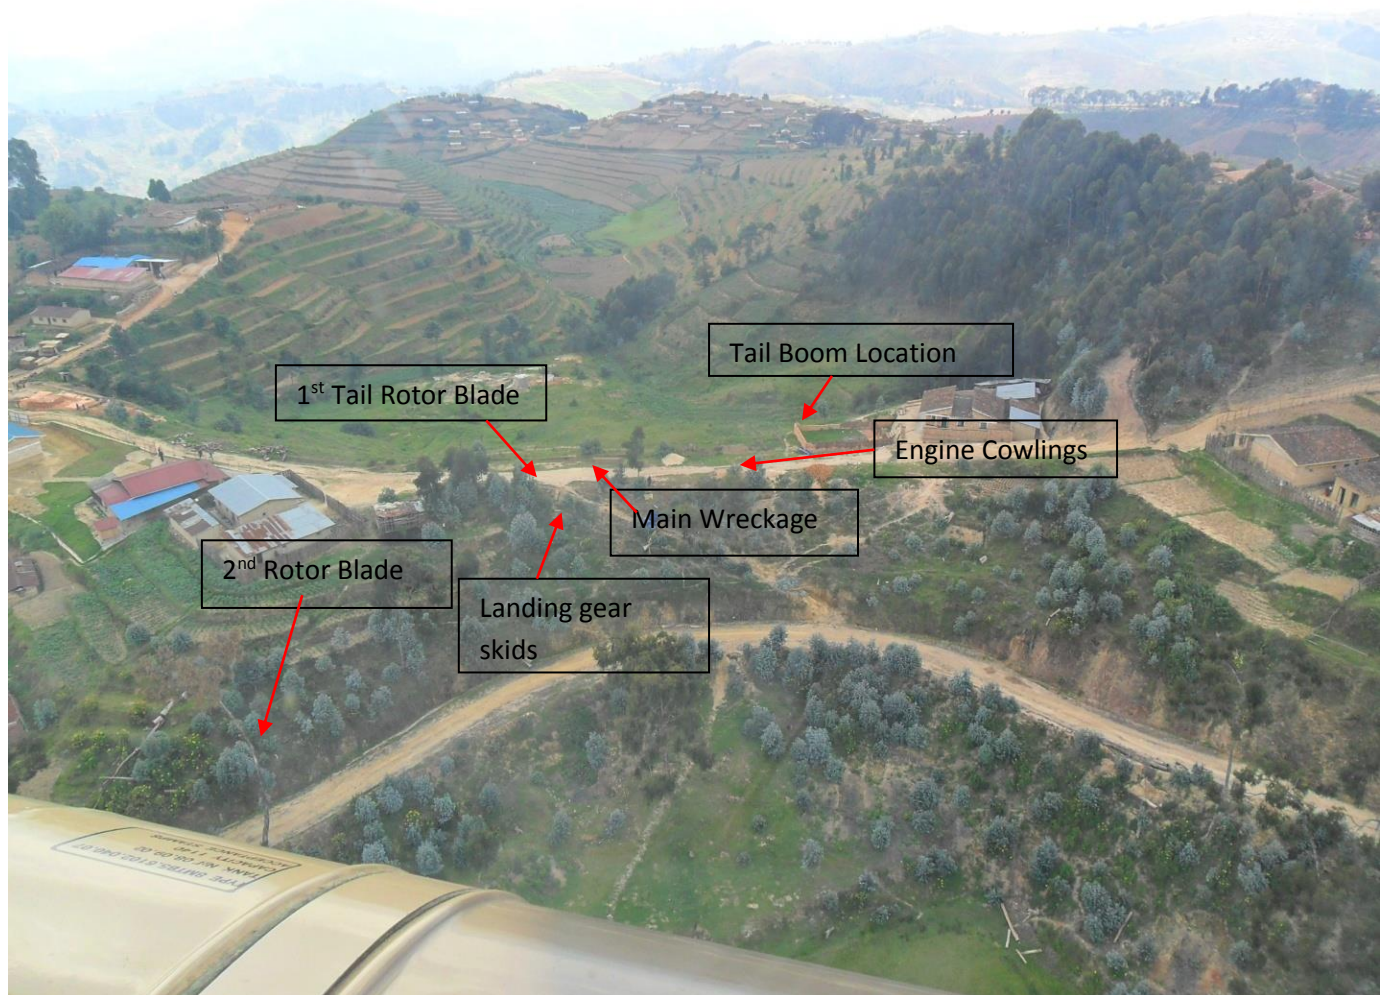
#### 1.12.1.1 Aerial Photograph

Detached landing gear skids were located within the area of the initial impact point in line with the flight path. An engine cowling was located approximately 4 meters ahead of the main wreckage. The tail boom, together with the tail rotor shaft and hub, was located 25 meters and 45 degrees right of the main wreckage. Most components were still attached to or located near the main wreckage except for TRB that was found about 100 meters west of the wreckage.

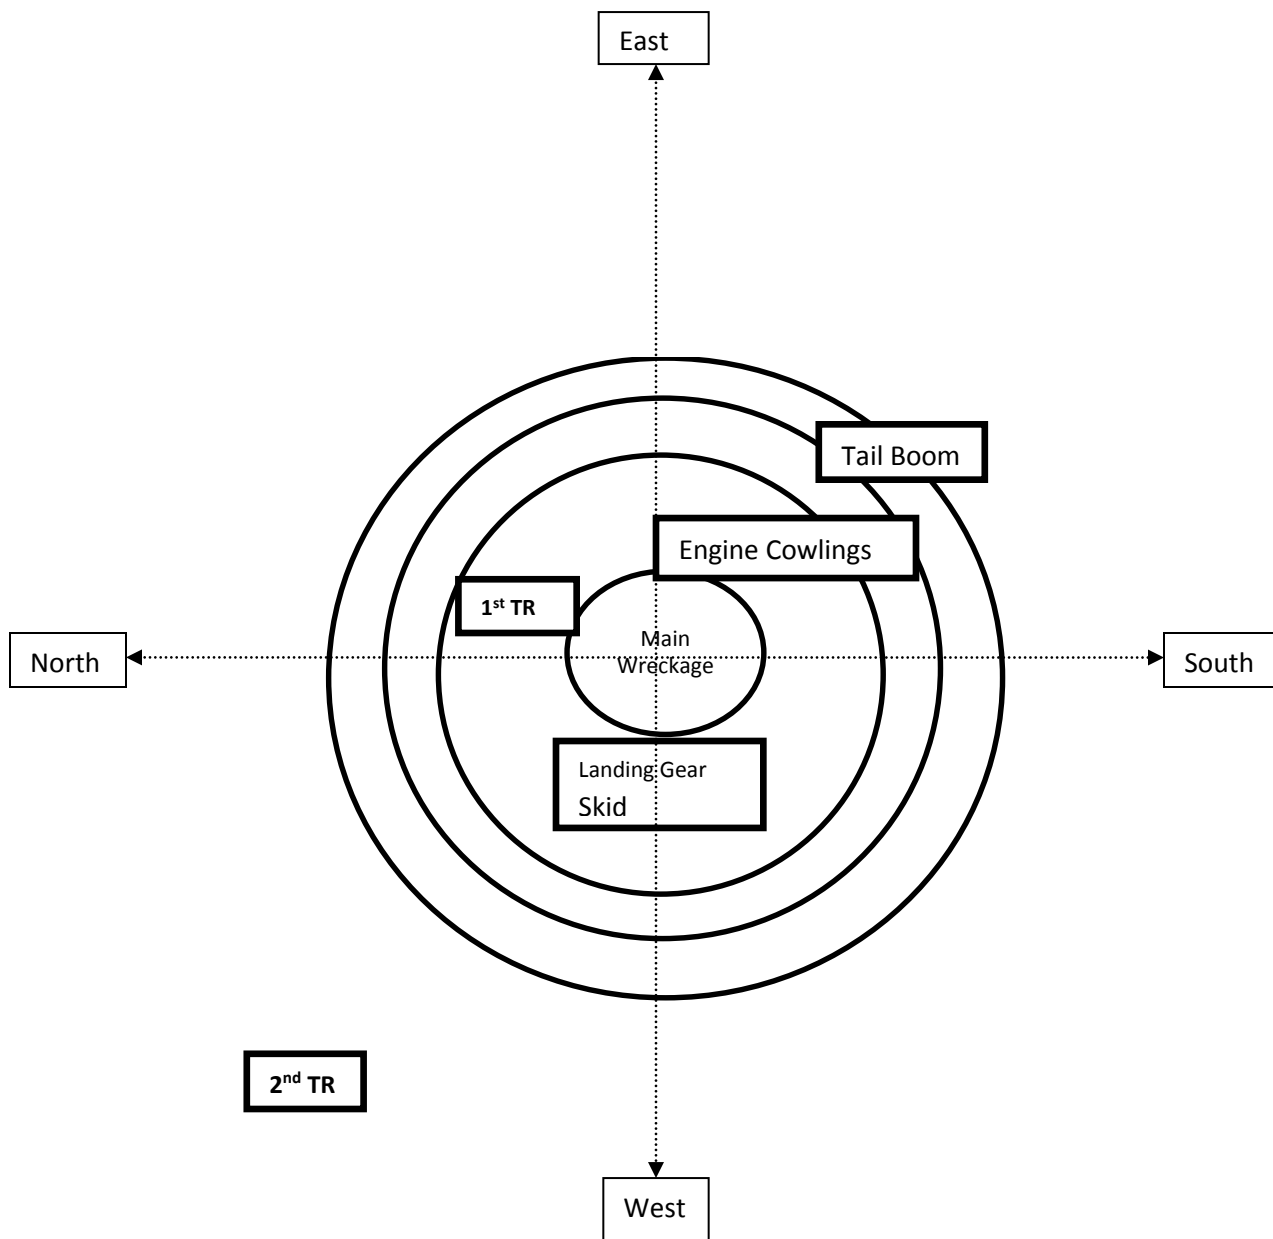
#### 1.12.1.2 Scatter Diagram showing relative location of major components

The tail boom, with the  $\frac{3}{4}$  of the tail rotor shaft, vertical and horizontal stabilizers attached, was located approximately 25 meters ahead and 45 degrees right of the main wreckage. See wreckage distribution shown under 1.12.1.1 and 1.12.1.2. Examination of the lower vertical stabilizer exhibited a semi circular indentation, black and yellow paint smug on the leading edge from the root to the tip. The upper vertical stabilizer did not sustain any damage. The horizontal stabilizer sustained ground collision damage. The two tail rotor blades (TRB), which had fractured close to the blade shanks, were located one about five meters north of the main wreckage and the other about 100 meters west of the main wreckage. Examination of both tail rotor blades and tail boom fractured surfaces exhibited some bending and shear forces.
